Manhole Inspection Summary

Manhole # S69S__018MH

Insp Date: **4/22/08 9:51 AM**

Location Address: **1600 Dundalk Ave.**

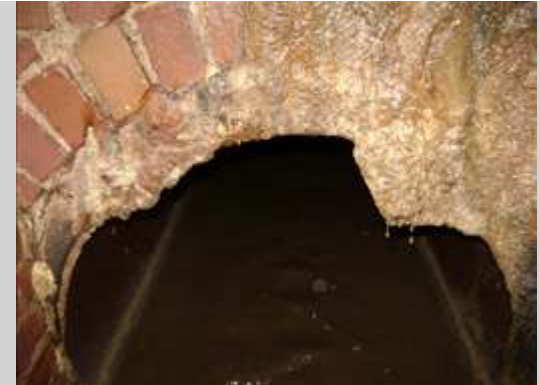
12 O'Clock Outflow

27 in. Circular Gravity Sewer
Pipe Out @ 12 O'Clock

Pipe Height: **26.4** (in.) Rod and Bar (Angled)
Pipe Material: **Clay** ☐ Pipe Lined
Invert Depth: **12.79** (ft.) Flow Characteristics: **Turbulent**
Deposits: ☒ None ☐ Mud ☐ Sludge ☐ Debris ☐ Grease
Silt Depth: (in.) Deposits Extent:
Infiltration: **None** Pipe Seal Cond: **Unknown**

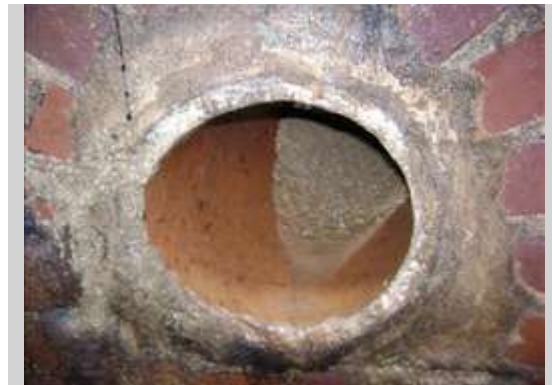
Drop In @ 3 O'Clock

Drop: **Inside** Rod and Bar
Angled: **Yes** Reading: **11.08** (ft.)
Inv Depth: **12.08** (ft.)
Drop Condition: **Open**

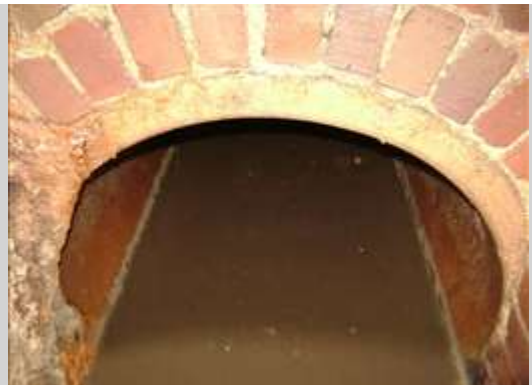
6 O'Clock Inflow

27 in. Circular Gravity Sewer
Pipe In @ 6 O'Clock

Pipe Height: **27.6** (in.) Rod and Bar (Angled)
